Crash Following Loss of Engine Power Due to
Fuel Exhaustion
Air Methods Corporation
Eurocopter AS350 B2, N352LN
Near Mosby, Missouri
August 26, 2011

NTSB/AAR-13/02
PB2013-104866

Aircraft Accident Report

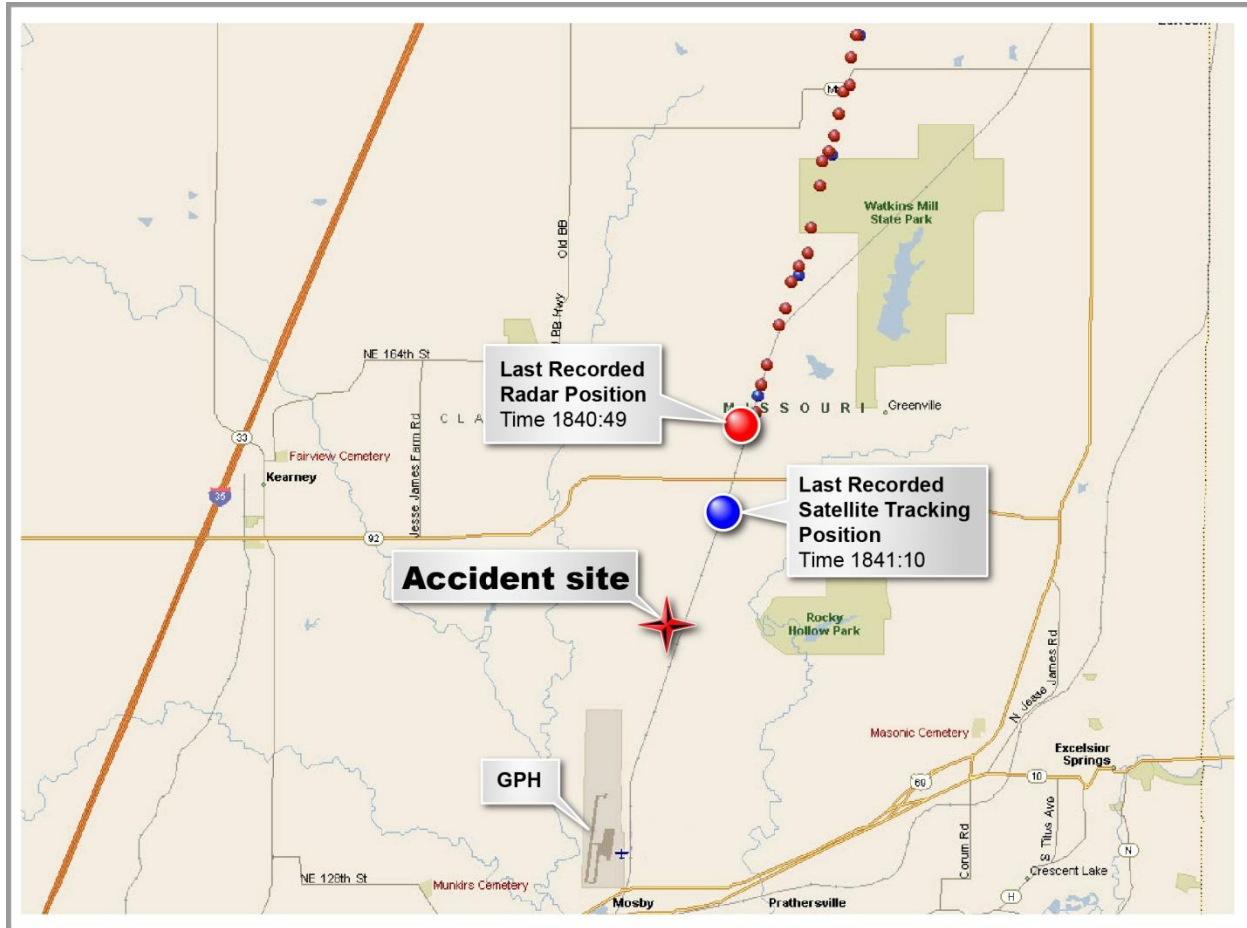
an average ground speed of 111 to 116 knots. The last few minutes of data showed the helicopter in a shallow descent. About 1841, the last satellite tracking system position recorded was about 0.9 nm from the accident site and showed the helicopter was about 373 feet agl with a 116-knot ground speed. Figure 3 shows the last few miles of flight track data.

Figure 3. Flight track of the last few miles of the accident flight showing radar data (red dots) and Air Methods satellite tracking system data (blue dots).

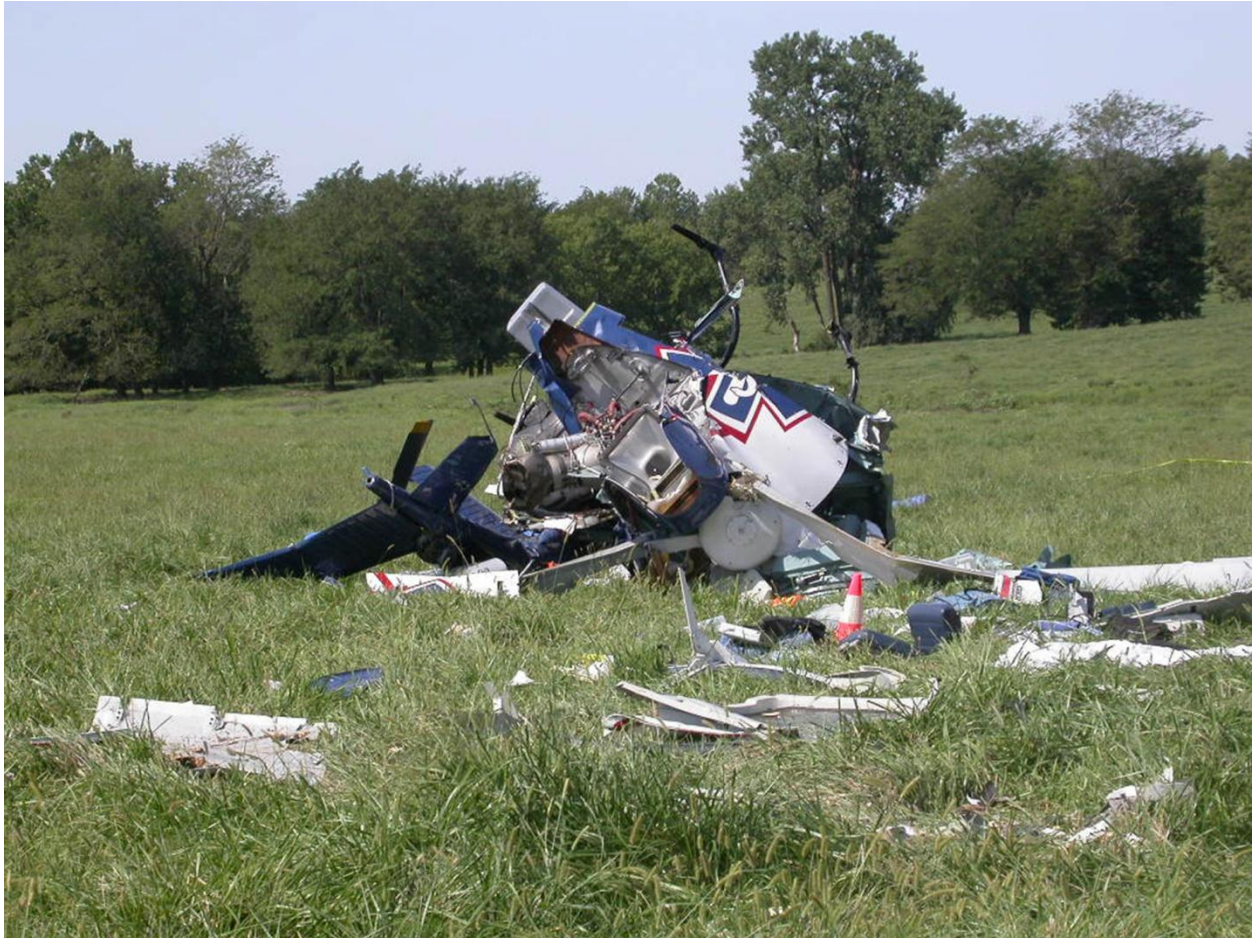
As shown in figure 4, the aircraft structure was heavily fragmented and scattered along a 100-foot-long debris path, which was oriented on a heading of about 242°.

Figure 4. Photograph of the accident site.

The wreckage displayed vertical crush damage consistent with impact at a high rate of descent. The main rotor blades remained attached to the rotor hub, were bent but not twisted, and had minimal leading-edge damage. Similarly, the tail rotor blades exhibited little impact damage and were relatively straight, although one blade was partially separated at the blade root. The damage to the main and tail rotor blades was consistent with a low rotor rpm at impact. The impact signatures to the components of the airframe structure were consistent with the initial impact occurring in a 40° nose-low and slight left-bank attitude, on a heading of about 030° (nearly opposite to the direction of travel). Figure 5 is a diagram illustrating the estimated impact attitude of the helicopter.

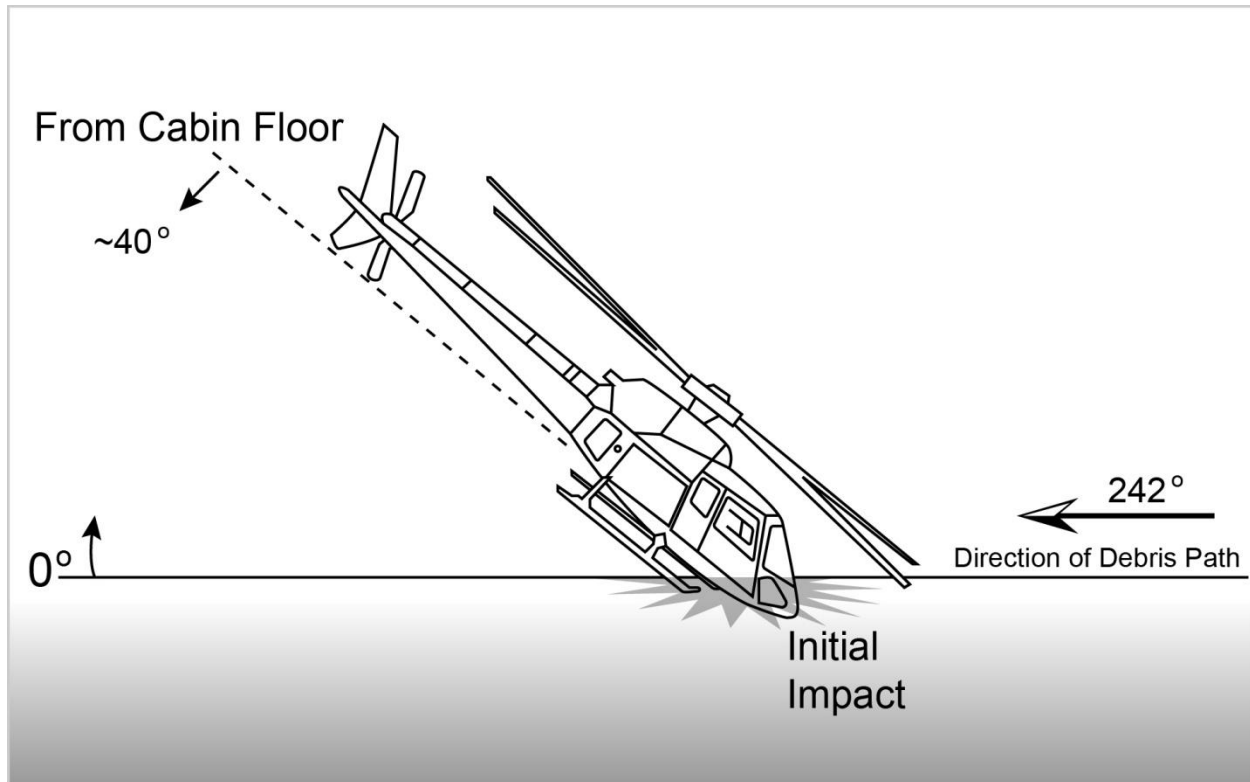
Figure 5. Diagram showing the estimated impact attitude of the helicopter.

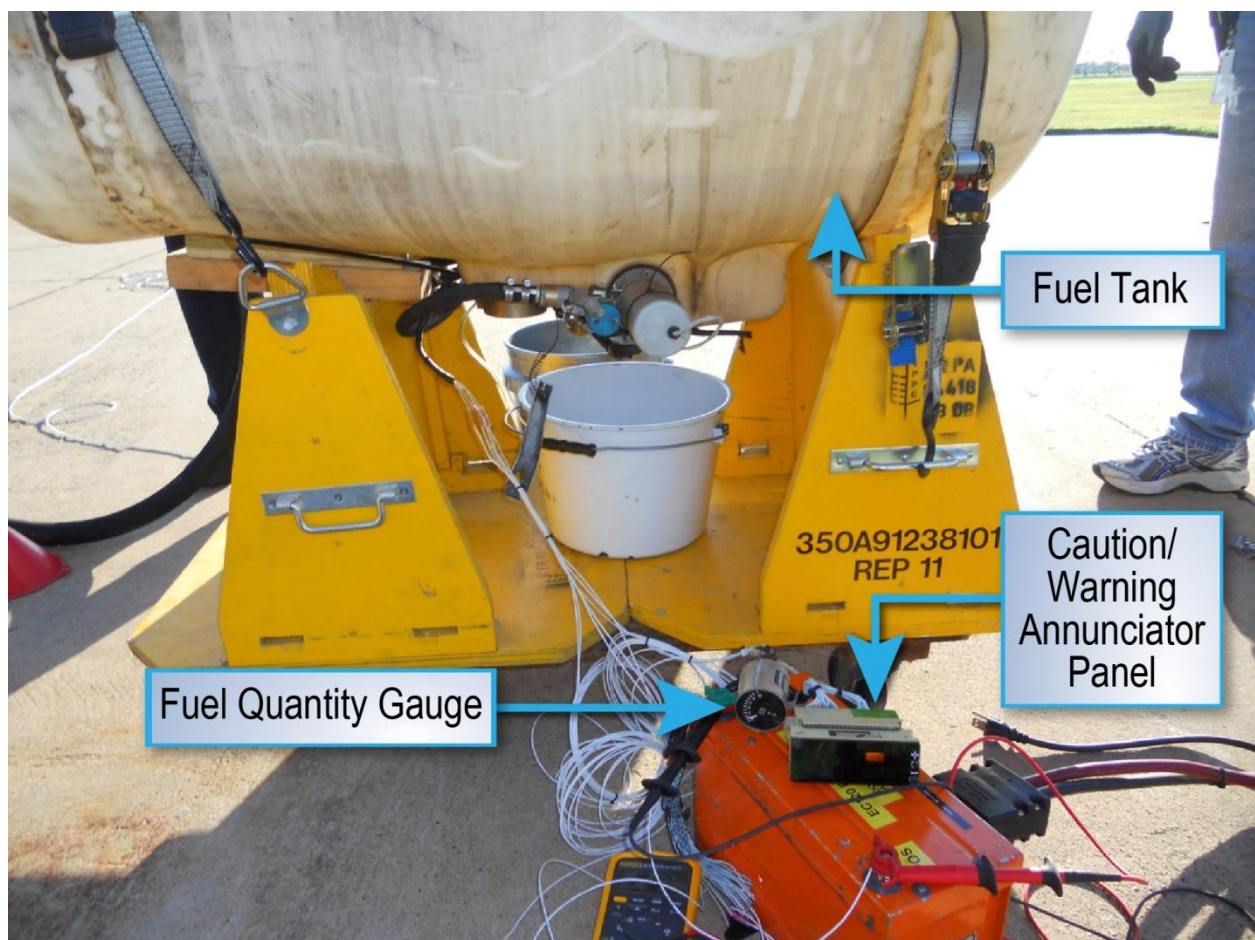
Figure 8. Photograph of the fuel system component examination setup.

An operational check of the caution/warning annunciator panel was performed and revealed that all lights were working properly. Examination of the individual light bulb filaments revealed that the filaments for both bulbs from the low fuel level light exhibited slightly stretched coils consistent with the light being illuminated at the time of impact.

The brightness switch on the caution/warning annunciator panel was found on the dim setting at the accident site. During the examination, the panel was illuminated in daylight conditions and observed in both bright and dim settings. With the panel in the dim position, only the low fuel pressure light (the only light that does not convert to the dim setting by design) was conspicuously illuminated. It was not possible to determine whether the panel was switched to the dim setting during the previous NVG training flight and never returned to bright for the accident flight, whether the panel was switched to the dim setting during the accident flight, or whether this setting occurred during impact.
