Aviation Investigation Preliminary Report

Location:	El Cajon, CA	Accident Number:	WPR22FA068
Date & Time:	December 27, 2021, 19:14 Local	Registration:	N880Z
Aircraft:	GATES LEARJET CORPORATION 35A	Injuries:	4 Fatal
Flight Conducted Under:	Part 91: General aviation - Positioning

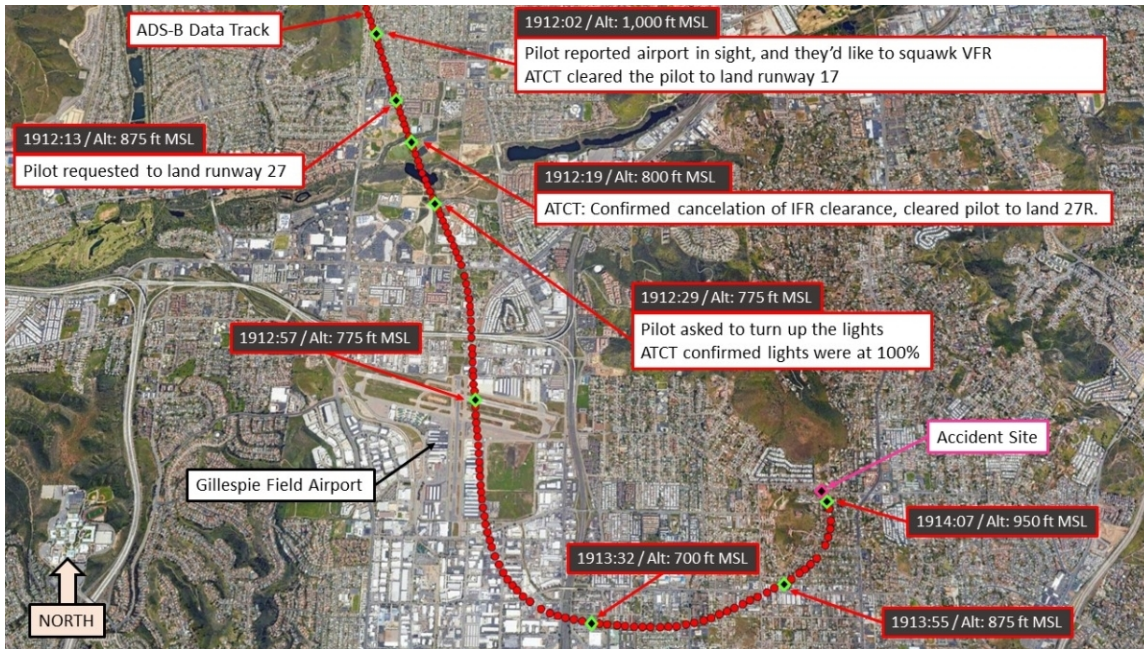
Preliminary Automatic Dependent Surveillance-Broadcast (ADS-B) data showed that after departure from SNA, the flight made a left turn out over the waters of the Pacific Ocean and flew generally south – southeast along the coast and ascended to a cruise barometric altitude of about 11,000 ft sea level (MSL). After the flight passed Carlsbad, California, the airplane turned left and began to descend toward SEE. As shown in figure 1, ADS-B data showed that the airplane overflew SEE at a barometric altitude of about 775 ft MSL (407 ft above ground level) and entered a left downwind for runway 27R. While on the downwind leg, the airplane descended to a barometric altitude of 700 ft MSL, then ascended to a barometric altitude of 950 ft MSL while on the base leg. The last recorded ADS-B target was at 1914:09, at a barometric altitude of 875 ft MSL.

Figure 1: Recorded ADS-B data with ATC communication annotations.
