# Aviation Investigation Preliminary Report

<b>Location:</b>	Montebello, VA	<b>Accident Number:</b>	ERA23FA256
<b>Date &amp; Time:</b>	June 4, 2023, 15:23 Local	<b>Registration:</b>	N611VG
<b>Aircraft:</b>	Cessna 560	<b>Injuries:</b>	4 Fatal
<b>Flight Conducted Under:</b>	Part 91: General aviation - Personal

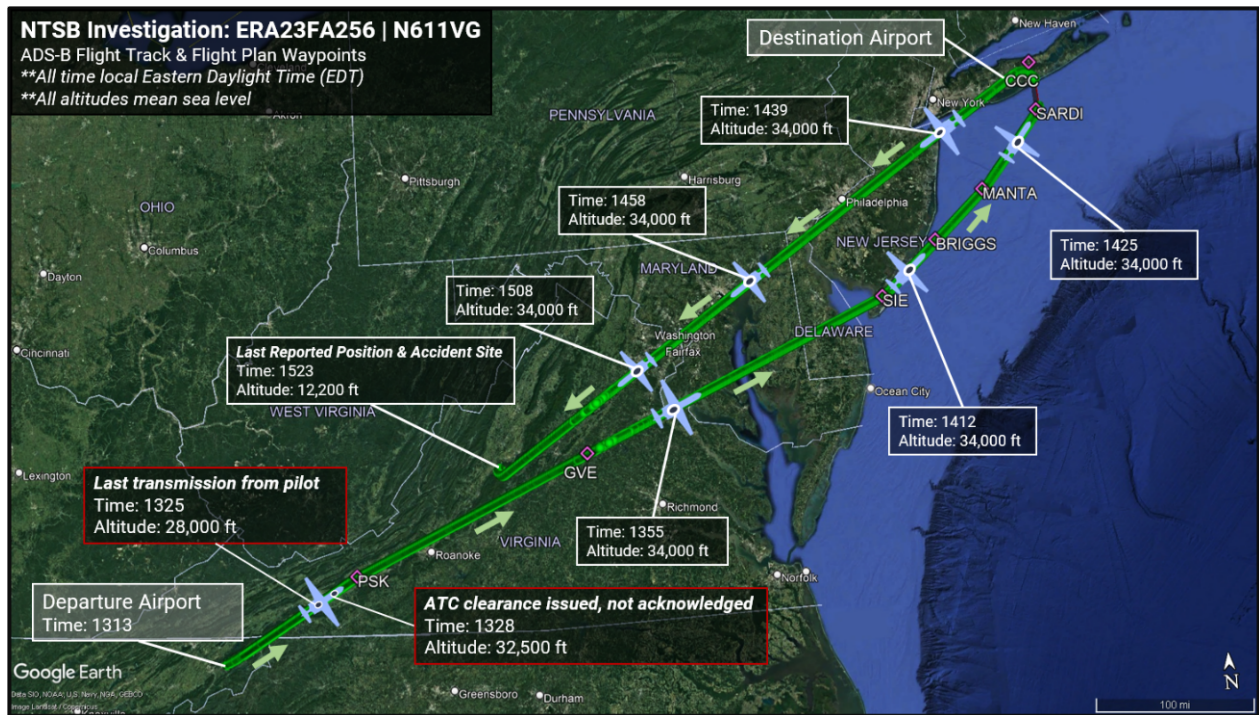
Review of preliminary Automatic Dependent Surveillance – Broadcast (ADS-B) data found that the airplane’s flight track to the destination airport was consistent with the filed flight plan route. The airplane arrived overhead of ISP at 1432, maintaining 34,000 ft throughout the flight. The airplane subsequently continued flying southwest on a ground track of about 240°. The track showed little deviation or altitude change until 1522, where the airplane entered a rapidly descending right spiral descent into terrain.

NTSB Figure: Overview of the ADS-B flight track, flight plan waypoints, and select time/altitude labels.
