# Aviation Investigation Preliminary Report

<b>Location:</b>	Houston, TX	<b>Accident Number:</b>	DCA24FA017
<b>Date &amp; Time:</b>	October 24, 2023, 15:20 Local	<b>Registration:</b>	N510HM (A1); N269AA (A2)
<b>Aircraft:</b>	TEXTRON AVIATION INC 510 (A1); RAYTHEON AIRCRAFT COMPANY HAWKER 850XP (A2)	<b>Injuries:</b>	4 None (A1); 3 None (A2)
<b>Flight Conducted Under:</b>	Part 91: General aviation - Personal (A1); Part 135: Air taxi & commuter - Non-scheduled (A2)

On October 24, 2023, about 15:20 central daylight time, a Raytheon Hawker 850XP, N269AA, was taking off on runway 22 when its left wing collided with the vertical stabilizer of a Textron Aviation (Cessna) Citation Mustang, N510HM, that was landing on runway 13R at William P. Hobby Airport (HOU), Houston, Texas. Day visual meteorological conditions prevailed at the time of the accident.

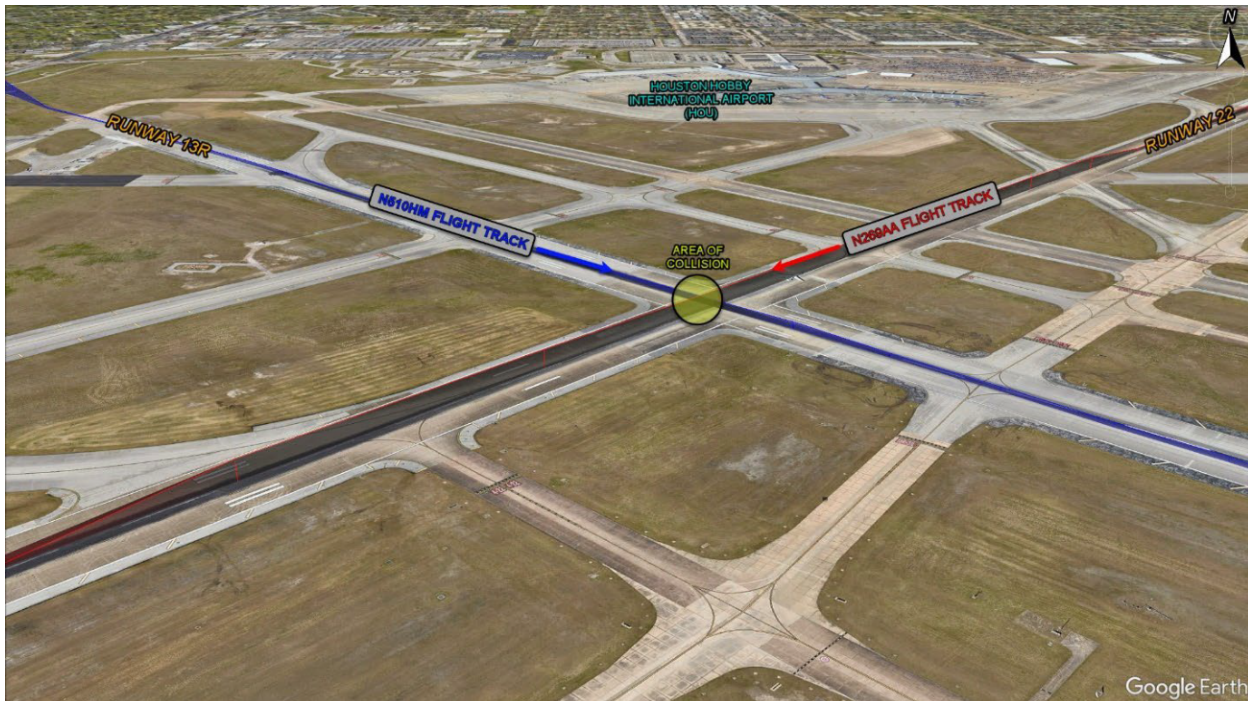
HOU has intersecting runways, and the local controller had instructed the crew of N269AA to line up and wait (LUAW) on runway 22. The crew of N269AA said in a post-accident interview that they believed they heard that they were cleared for takeoff when they took off. The collision between the two airplanes occurred at the intersection of the two runways, see figure 1.

**Figure 1.** View of both airplanes flight tracks with the area the ground collision occurred highlighted in yellow. The blue line represents N510HM, and the red line represents N269AA.

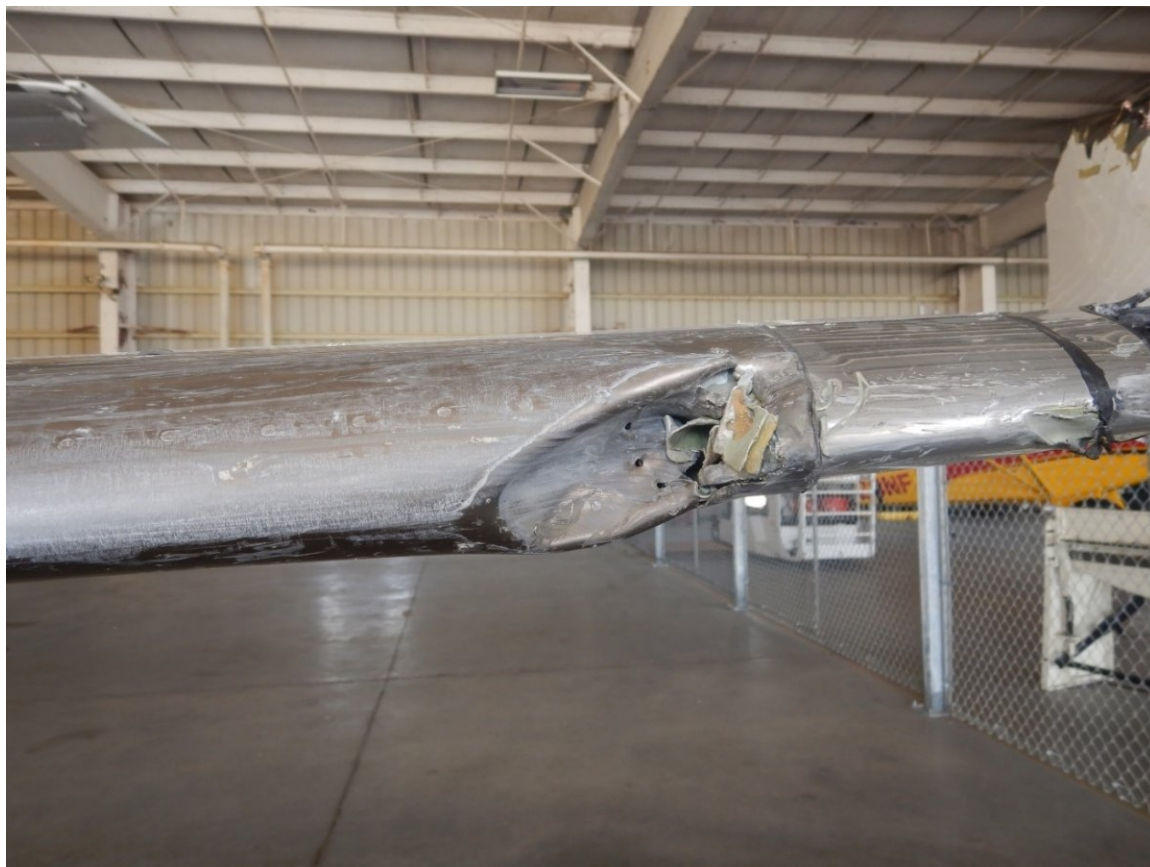
Post-accident examination of N269AA revealed that the left wing exhibited impact damage. The titanium leading-edge panel exhibited a “V-shape” aft indentation to the wing front spar with sheet metal remnants of the Cessna Mustang embedded, see figure 2.

**Figure 2.** Close up view of N269AA's left-wing leading-edge damage.

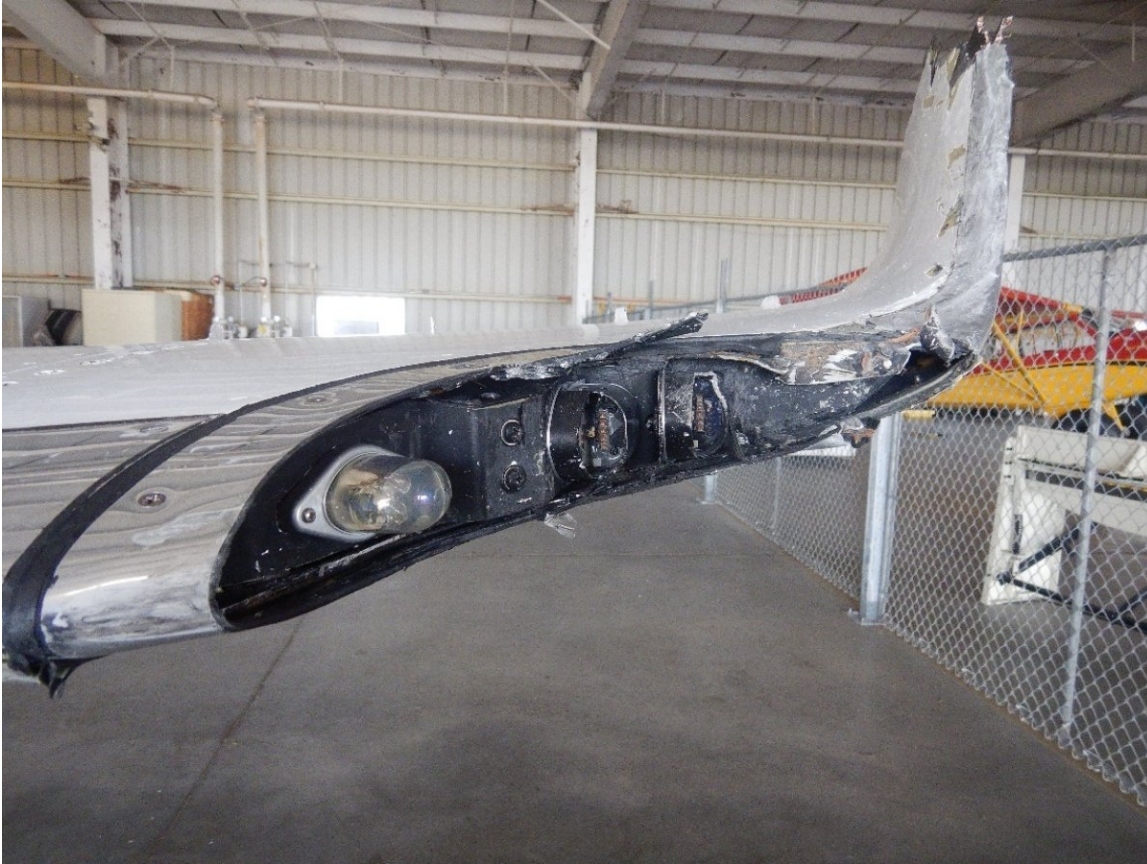
N269AA’s left-wing winglet remained attached to the left wing. The winglet leading edge exhibited white paint transfer marks and the navigation light lens was impact separated and pieces of the glass were found in the Cessna Mustang’s tail cone/stinger. About ten inches of

the top section of N269AA's winglet had separated due to the impact with N510HM, see figure 3.

**Figure 3.** Close up view of N269AA's left winglet/navigation light assembly damage.

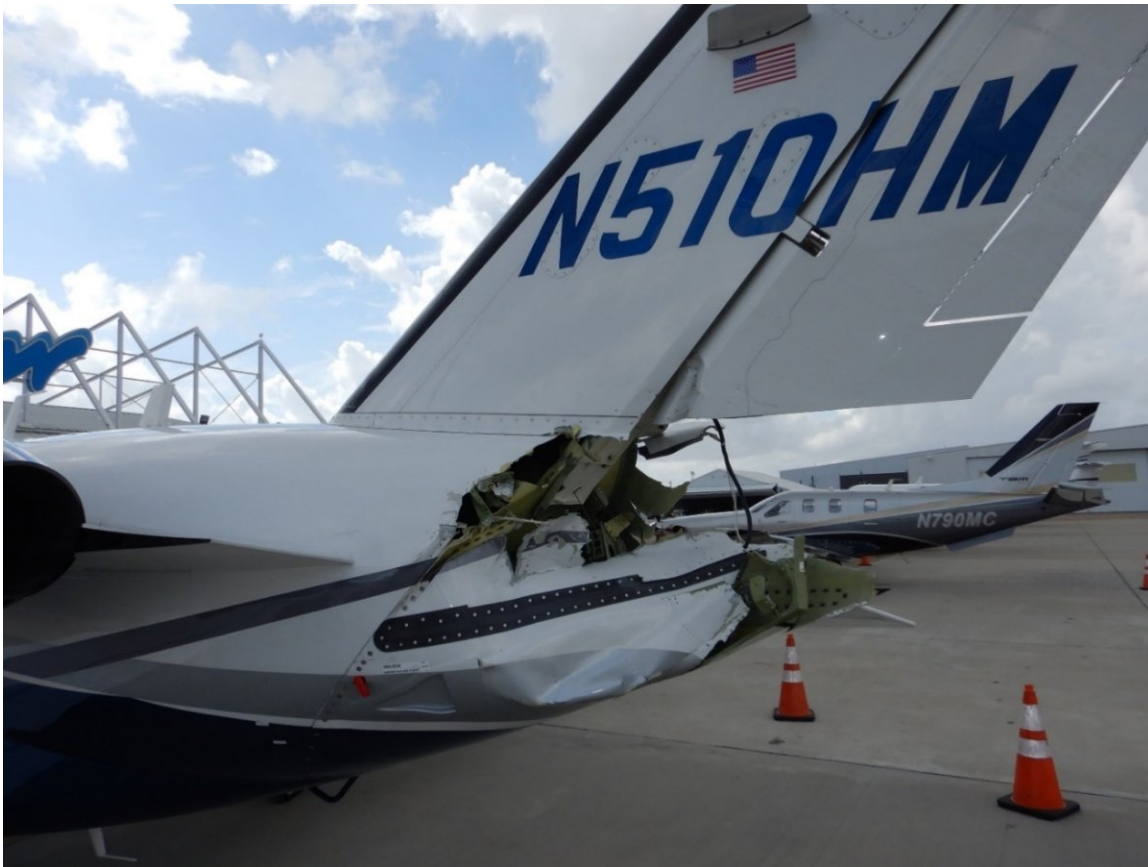
Post-crash examination of N510HM revealed that the left side of its tail section had been impacted by the left wing of N269AA. The torn skin on the tail section was consistent with N269AA's wing penetrating the left side of N510HM's tail stinger and exiting the right side, severing a portion of the stinger. The impact damage was isolated to the area of the empennage, see figures 4, 5 and 6.

The impact fractured and separated a section of the aft canted bulkhead. A section of the aft horizontal stabilizer spar; common to the rudder sector attach point, was torn and bent consistent with the wing impact. The rudder sector mount was torn from the structure at the fastener locations.

The rudder torque tube was fracture separated from the rudder control sector and the rudder. The upper and lower left and lower right rudder control cables were broken in a manner consistent with tensile overload. The upper right rudder control cable remained intact, but the ball end was pulled from the rudder sector. The autopilot rudder servo control cable was fractured in tensile overload. The left autopilot cable pulley bracket, with pulley attached, was separated from the canted bulkhead. The left strake was impact fractured from the tail cone stinger and was recovered from the runway along with various sheet metal fragments from the stinger.

**Figure 4.** Left side view of N510HM's damage to its empennage.

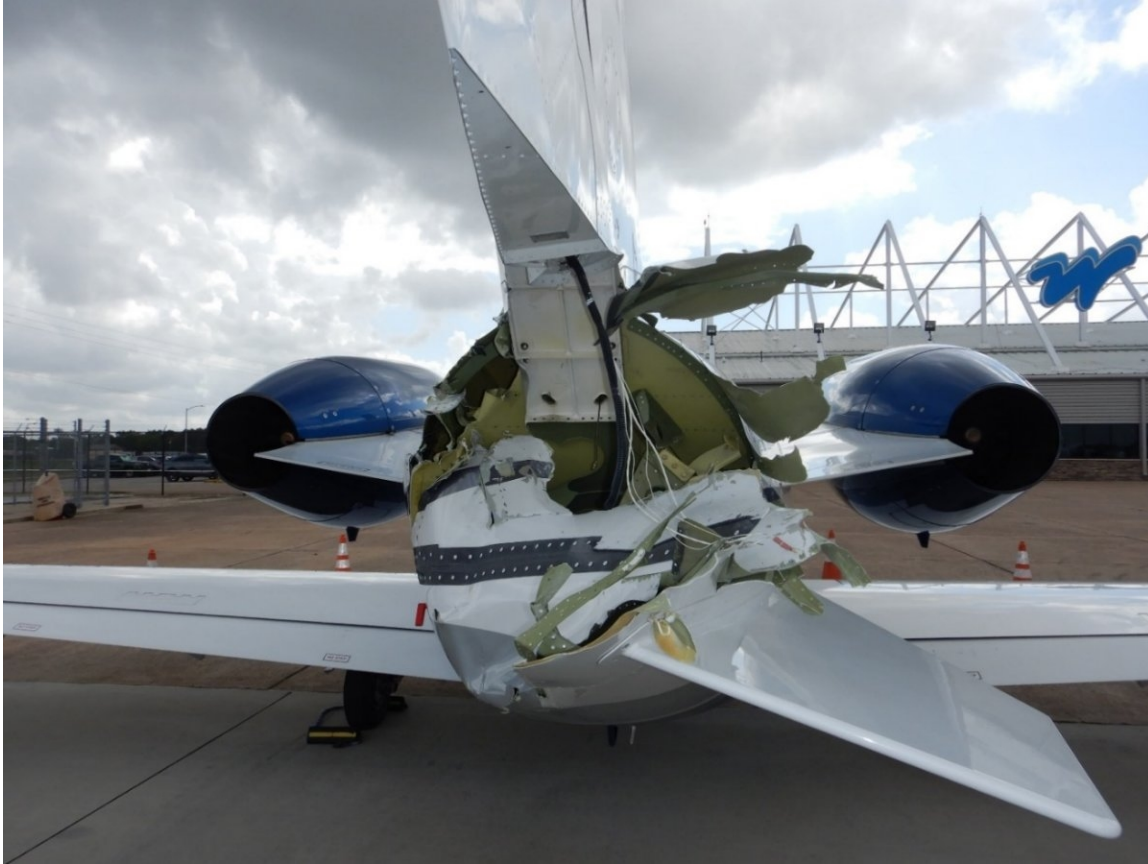
**Figure 5.** Aft view of N510HM's damage to its empennage.

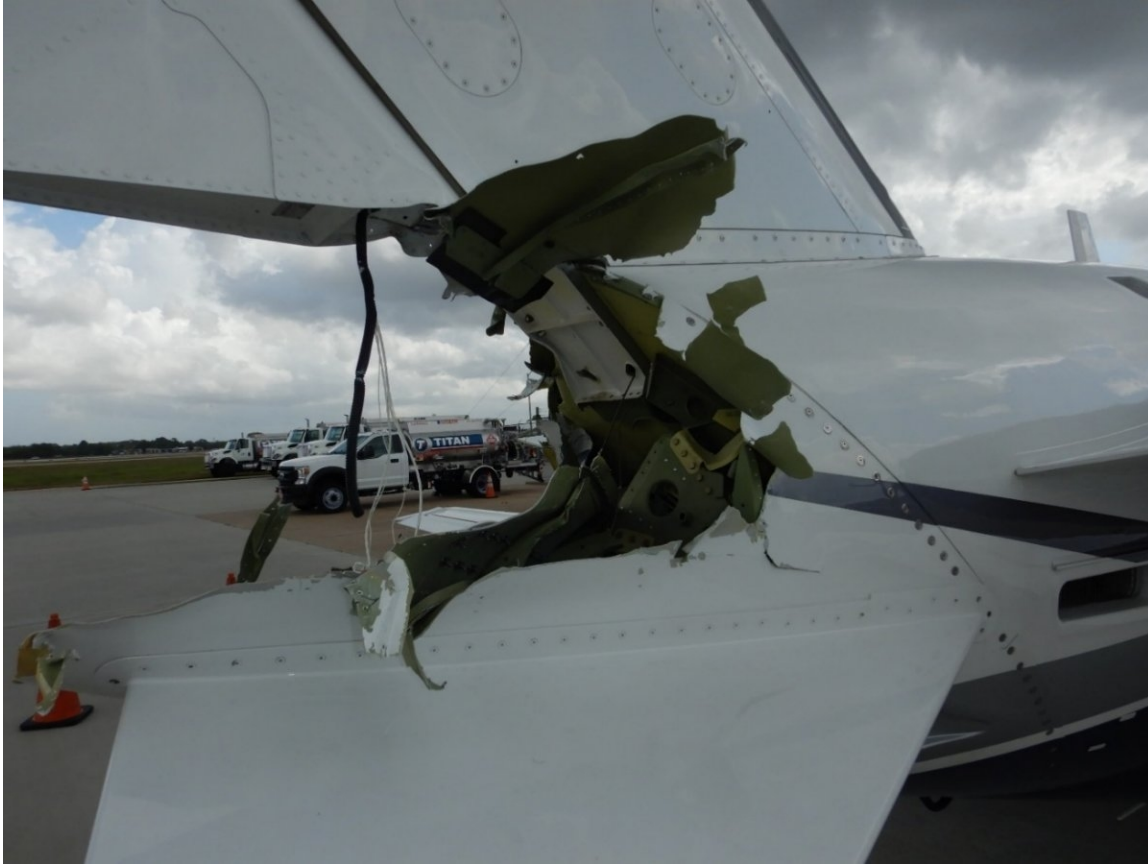
**Figure 6.** Right side view of N510HM's damage to its empennage.
