# Aviation Investigation Final Report

<b>Location:</b>	Kaupo, Hawaii	<b>Accident Number:</b>	ANC23FA008
<b>Date &amp; Time:</b>	December 15, 2022, 21:14 Local	<b>Registration:</b>	N13GZ
<b>Aircraft:</b>	RAYTHEON AIRCRAFT COMPANY C90A	<b>Aircraft Damage:</b>	Substantial
<b>Defining Event:</b>	Inflight upset	<b>Injuries:</b>	3 Fatal
<b>Flight Conducted Under:</b>	Part 91: General aviation - Positioning

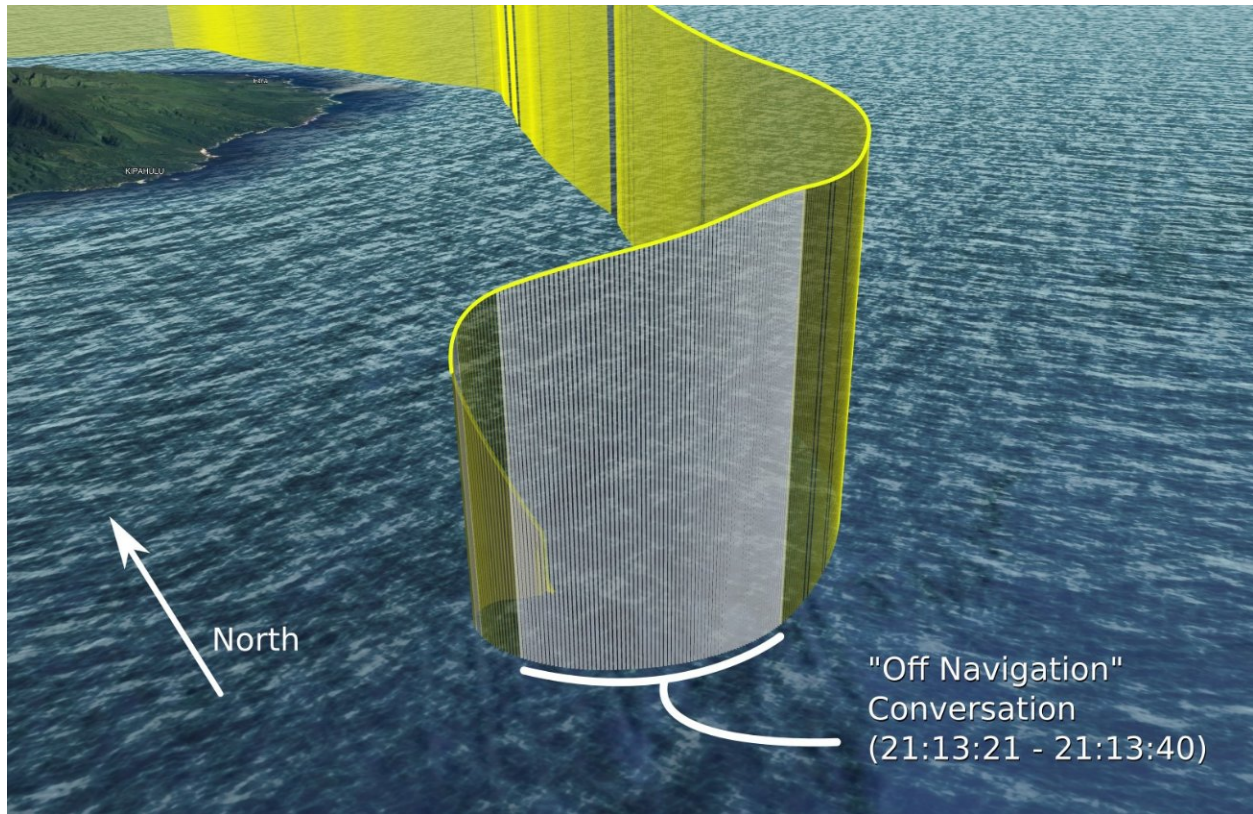
At 2113:40, the pilot replied: "Uhh, 13GZ is off navigation here... we're gonna... we're gonna give it a try." The vertical speed indicator was pegged at -3,500 fpm (see Figure 2).

*Figure 2. Google Earth image of a portion of the flight track.*

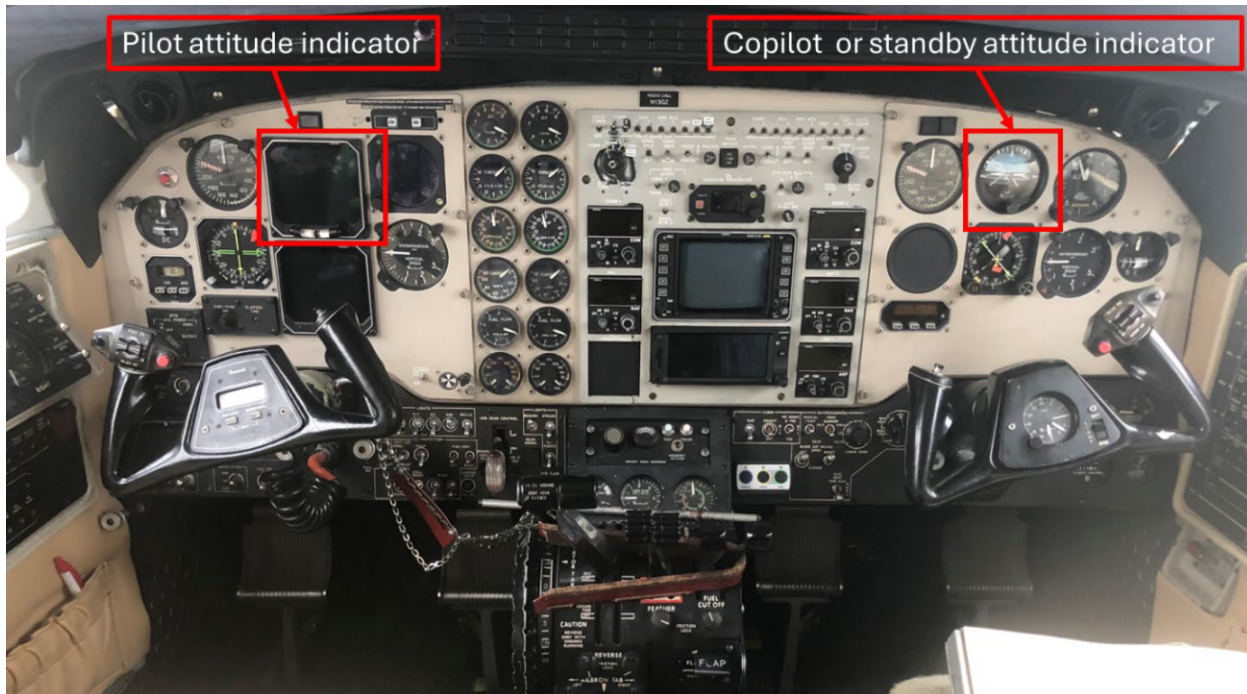
Figure 5. Illustrated instrument panel of the pilot attitude indicator and copilot or standby attitude indicator.

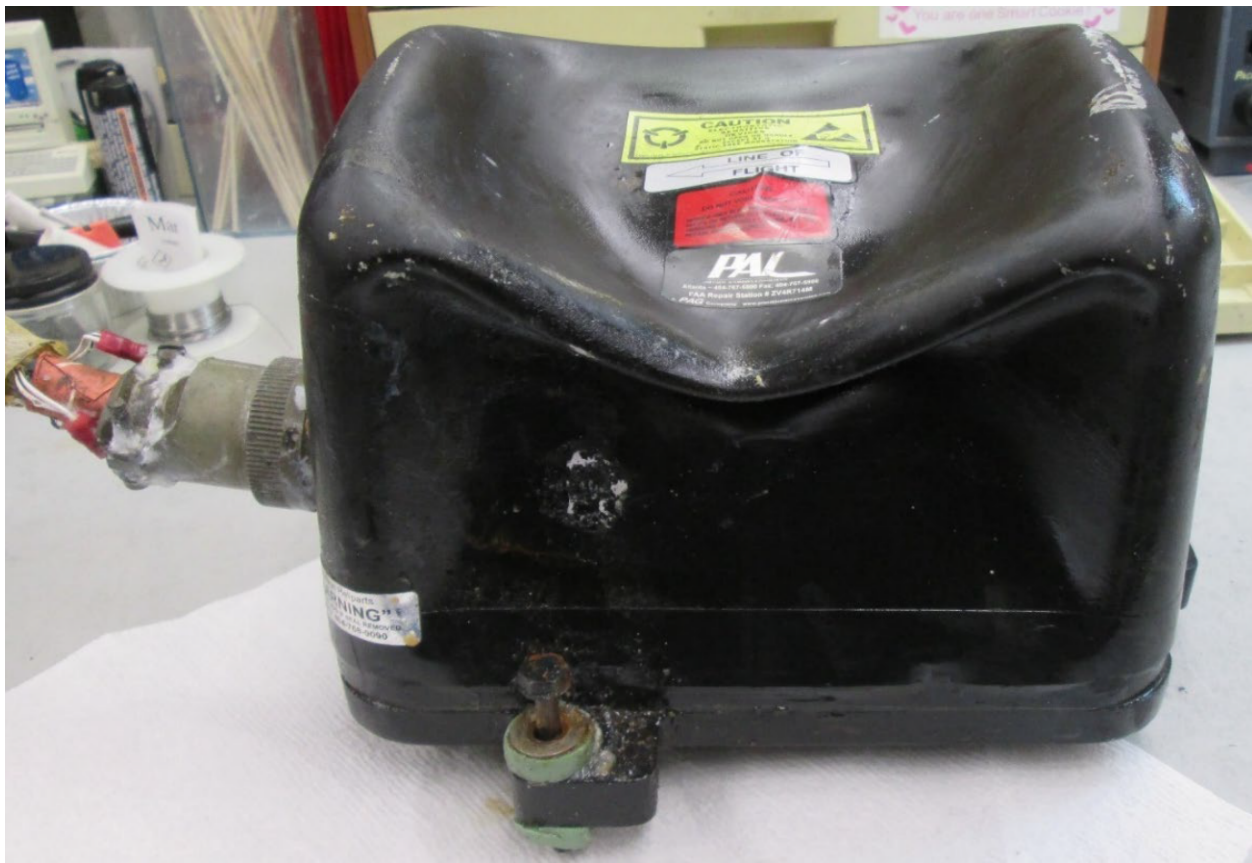
A postaccident examination of the vertical gyro was performed. The unit was crushed inward on the top and 2 sides (see Figure 6).

*Figure 6. View of inward crushing on the vertical gyro housing.*

The crushing of the case is consistent with excessive external water pressure. There were salt deposits on the electrical connector. The airframe electrical connector was removed. The pins were straight. The sockets on the aircraft side of the connector were present and none appeared to be recessed. The preservation sealing tape around the base of the unit was removed. Water was present and was drained from the unit. The cover was removed. The interior of the unit was covered in marine growth and deposits. The unit was washed with de-ionized water and some of the marine growth was removed (see Figure 7).

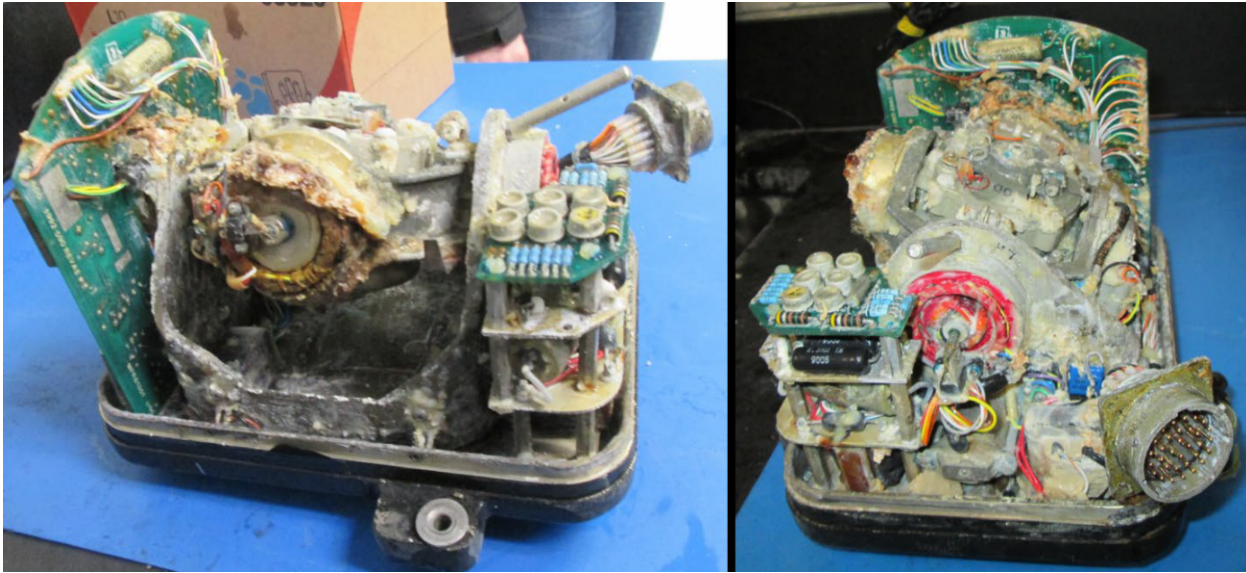
*Figure 7. Corrosion and marine growth inside the vertical gyro.*

The slip ring was damaged, and the damage appeared to correspond to the crushed cover. Several components on the unit were observed to be crushed. The S1 switch was broken, and the damage appears to correspond to the crushed cover. Damage to wire wound resistor (R61) on terminal board 7 (TB7) was observed. The resistance across the resistor was measured at 83.5 ohms as found. One of the wires between the resistor and the board was cut to isolate the resistor. The resistance across the resistor was re-measured at 83.4 ohms. (Note that the R61 resistor has a nominal value of 82 ohms.)

Continuity checks were performed on the electrical connector of the unit. Operation of the unit was not possible due to deposits on the unit. The area where the R61 resistor was located showed some corrosion deposits but no thermal damage. No other anomalies were observed during the examination.

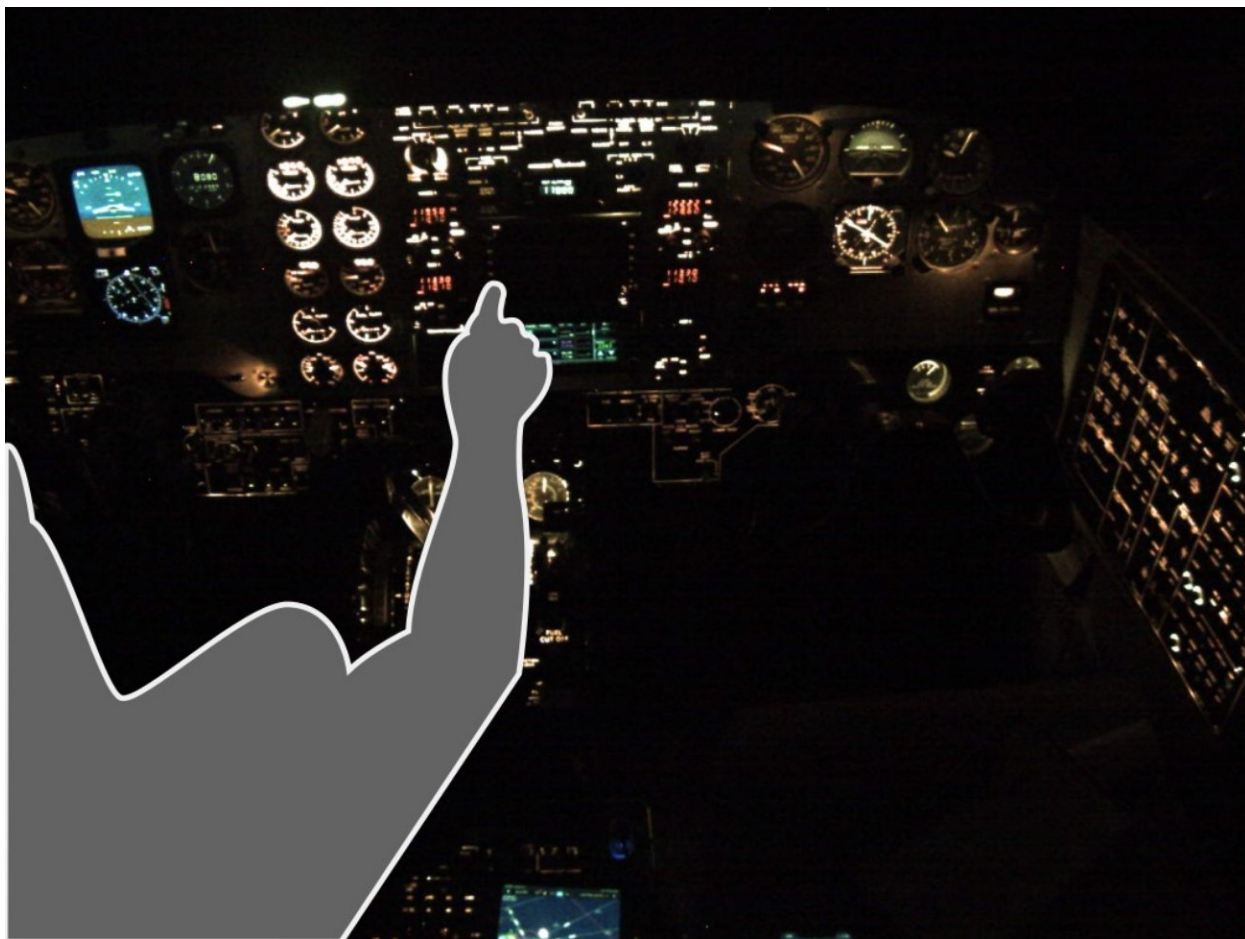
to listen to music after takeoff; the Collins MFD being inoperative for the duration of the flight; and the Electronic Flight Instrument System, which included the EADI on the captain's side (or left side), going black or inoperative approximately 13 minutes into the flight (see Figure 9). Additionally, the Appareo system captured audible sounds including the autopilot disconnect, master caution, altitude alert tones, and the sound of a loud metallic bang.

*Figure 8. Appareo image of accident flight.*

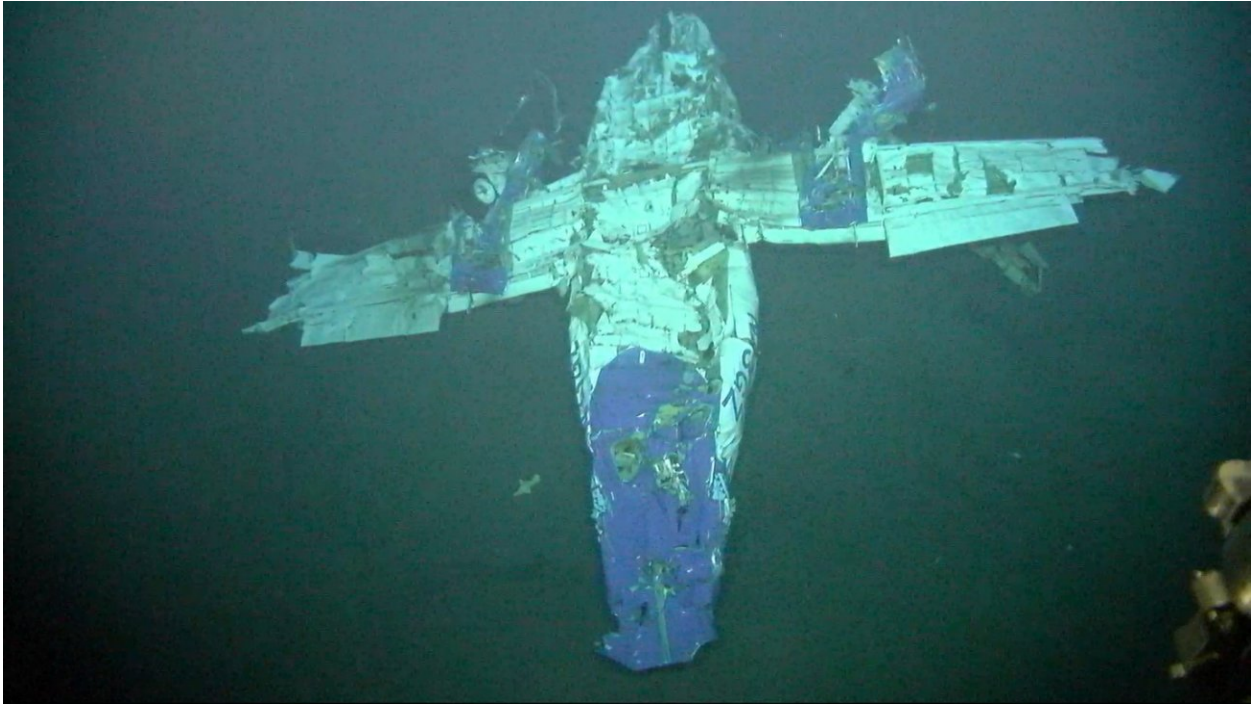
The postaccident examination revealed that the wreckage displayed vertical crush damage consistent with impact at a high rate of descent. The fuselage, from the nose to tail section, was impact damaged and compressed upward. The empennage separated from the fuselage in flight and was not recovered. The left and right wings were mostly intact but damaged from the wing roots out to beyond the end of the outboard flaps; neither wing tip was recovered. The lower surface of the wings had significant upward hydraulic compression damage. All wing separations exhibited signatures consistent with tension overload.

*Figure 14. View of N13GZ on the seabed. (Courtesy of Ocean Infinity)*
