Aviation Investigation Final Report

Location:	Pulaski, Tennessee	Accident Number:	ERA24FA058
Date & Time:	December 7, 2023, 11:03 Local	Registration:	N5891J
Aircraft:	Beech 35-C33	Aircraft Damage:	Destroyed
Defining Event:	Loss of control in flight	Injuries:	2 Fatal
Flight Conducted Under:	Part 91: General aviation - Personal

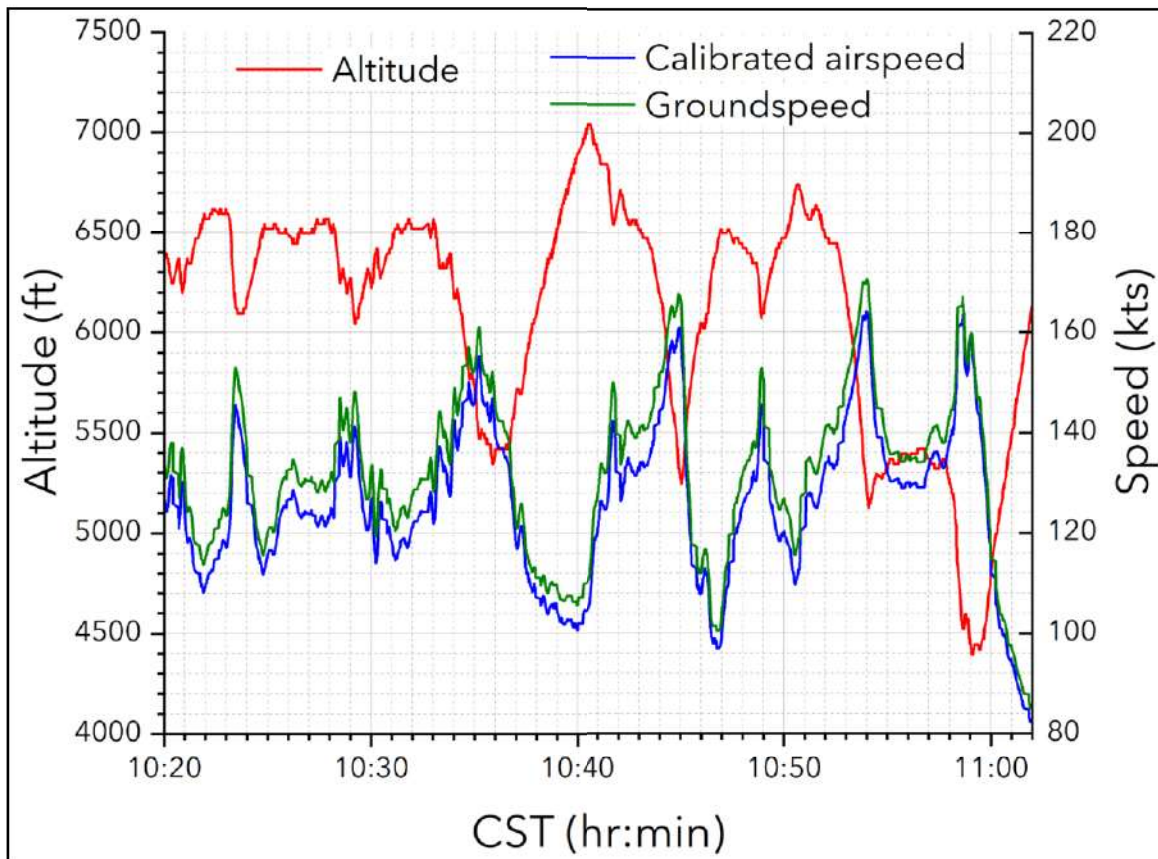
An aircraft performance study was conducted with ADS-B data, and the Beechcraft Debonair 35-C33 and Bonanza E33 F33 Pilot's Operating Handbook and FAA Approved Airplane Flight Manual. The study indicated that, at 1033, the altitude and speed fluctuations became more pronounced and that the airplane no longer maintained a steady altitude for any significant amount of time. Weather conditions from the time of the accident indicated that the calibrated airspeed was about 5 kts lower than the groundspeed (figure 1). The airplane gained airspeed while descending and slowed while climbing. Airspeed fluctuated between 100 and 160 kts while repeatedly gaining and losing 1,000 to 1,500 ft of altitude.

The rate of climb varied between -1,200 ft/min during the descents to near 500 ft/min during the climbs. Smaller variations in altitude during the climbs and descents were also observed.

Figure 1. Airplane altitude, calculated airspeed, and groundspeed for the final 40 minutes of flight.

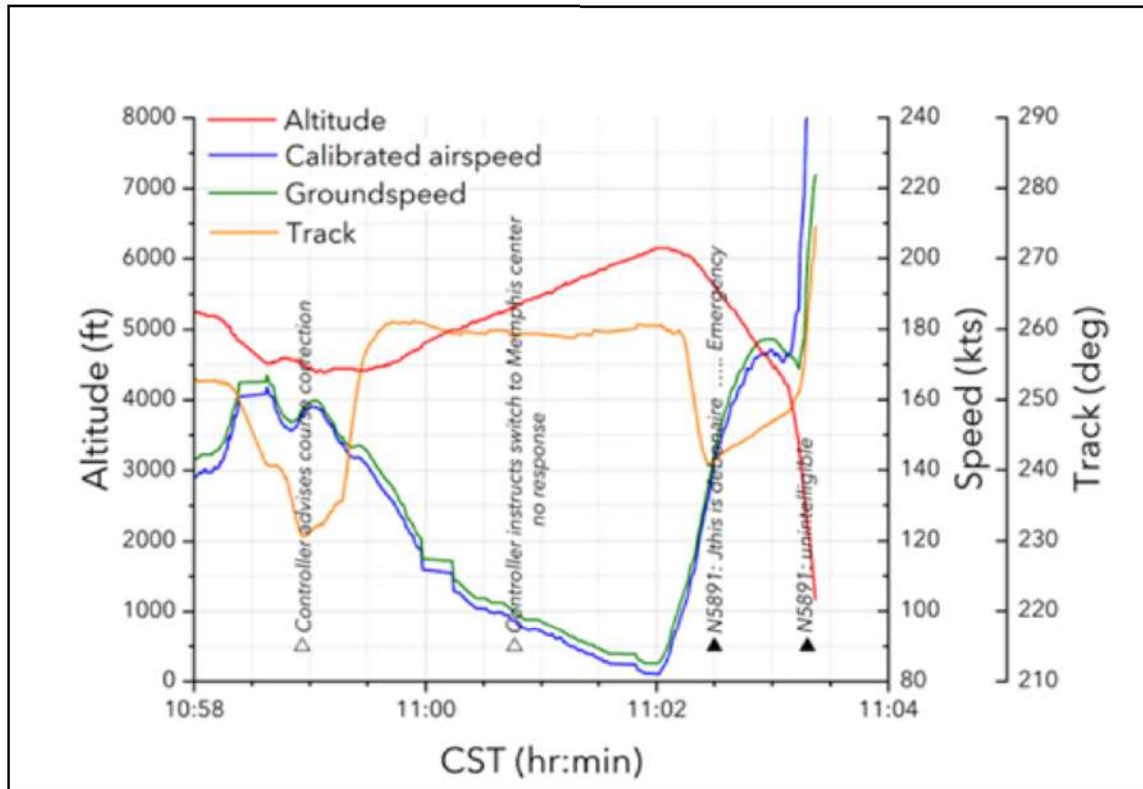
About 1103, there was a faint communication received from the pilot stating the “...this is Debonair, [unintelligible...] Emergency.” The transmission coincided with the airplane turning left, with a corresponding descent rate of about 2,000 ft/min and the airspeed increasing to over 170 kts (see figure 2). About 60 seconds later, a faint male voice transmitted, “[unintelligible], oh.... help us.” The controller’s subsequent attempts to contact the pilot were

unanswered, and there was no further communication from either the pilot or passenger. During this time, the airplane was in a rapid descent before radar contact was lost in the vicinity of the accident site. During the last several seconds of the flight, the airplane was on a ground track of 262° descending at an airspeed of 230 kts, and the descent rate was over 10,000 ft per minute.

Figure 2. Airplane altitude and track, with calculated airspeed and groundspeed and selected ATC communications, at the end of the flight.
