Aviation Investigation Preliminary Report

Location:	Philadelphia, PA	Accident Number:	ERA25MA106
Date & Time:	January 31, 2025, 18:07 Local	Registration:	XA-UCI
Aircraft:	Learjet 55	Injuries:	7 Fatal, 4 Serious, 20 Minor
Flight Conducted Under:	Part 129: Foreign

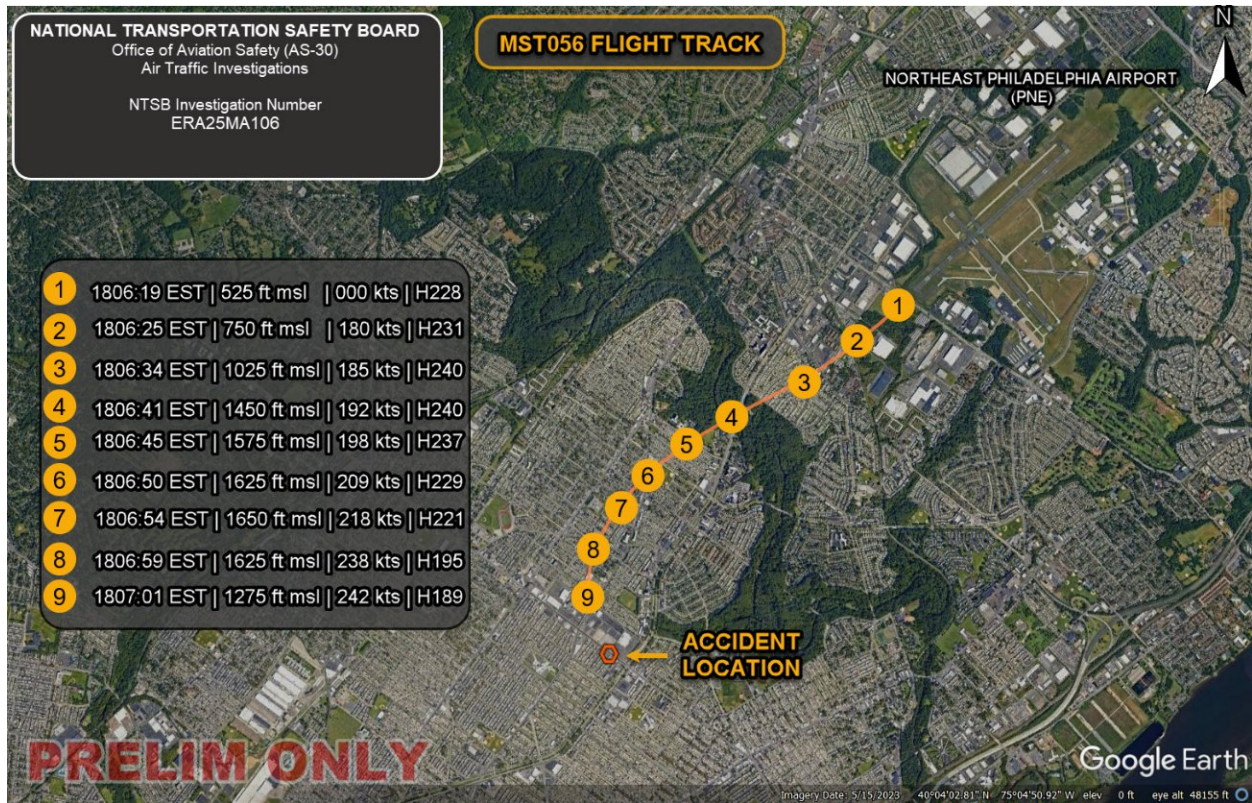
Preliminary ADS-B flight track data obtained from the Federal Aviation Administration revealed that the flight departed runway 24 at Northeast Philadelphia Airport (PNE), Philadelphia, Pennsylvania, about 1806, with the intended destination of Springfield-Branson National Airport (SGF), Springfield, Missouri. The airplane proceeded to the southwest before it turned right slightly and then entered a gradual left turn. The airplane continued in the left turn and reached an altitude of 1,650 ft mean sea level (airport elevation was 119 ft). The track data ended at 1807, at 1,275 ft msl, and at 242 knots ground speed. The duration of the flight was about 1 minute (see Figure 1).

Figure 1. Aerial image with the airplane's ADS-B flight track and the accident location overlaid.
