Crash Following Loss of Engine Power Due to
Fuel Exhaustion
Air Methods Corporation
Eurocopter AS350 B2, N352LN
Near Mosby, Missouri
August 26, 2011

NTSB/AAR-13/02
PB2013-104866

Aircraft Accident Report

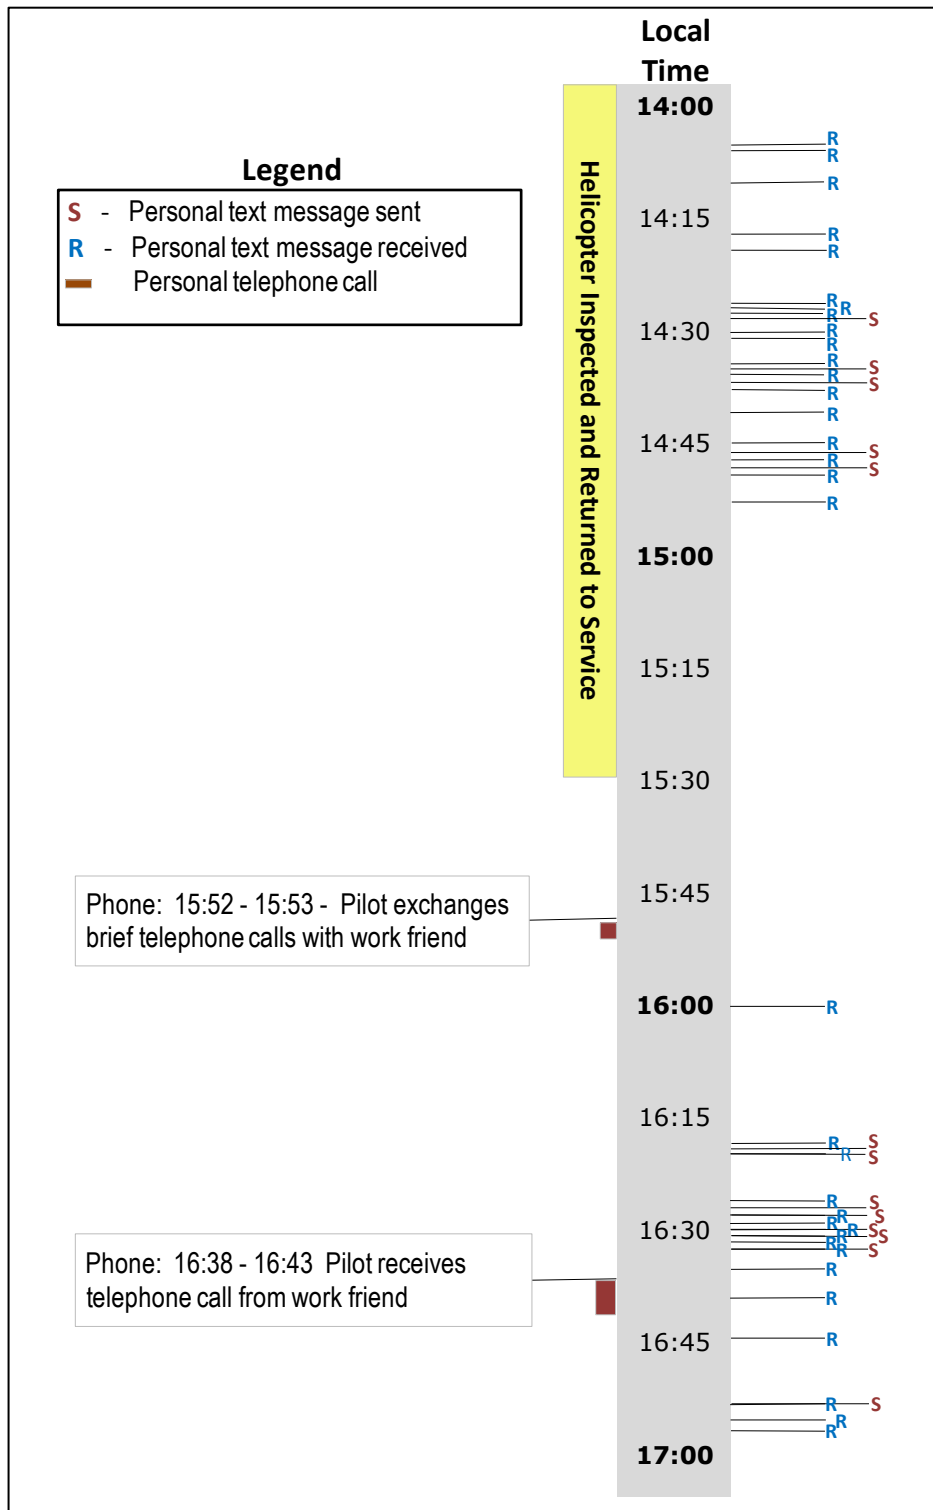
Figure 6a. Timeline of the pilot's communications from 1400 to 1700.

According to cell phone records, the pilot made and received multiple personal calls and text messages throughout the day. Figures 6a and 6b show the timing of the cell phone calls and text messages with the timing of radio communications and flight activities from 1400 (the time identified by the mechanic as when he and the pilot began the walk-around inspection) until the accident about 1841. Figure 6a, which covers the time period from 1400 to 1700, shows that

during about 20 minutes (1430 to 1450) of the 90-minute time period (1400 to 1530) identified by the mechanic as when the helicopter was being prepared by the pilot and medical crew for its return to service, the pilot sent multiple text messages.

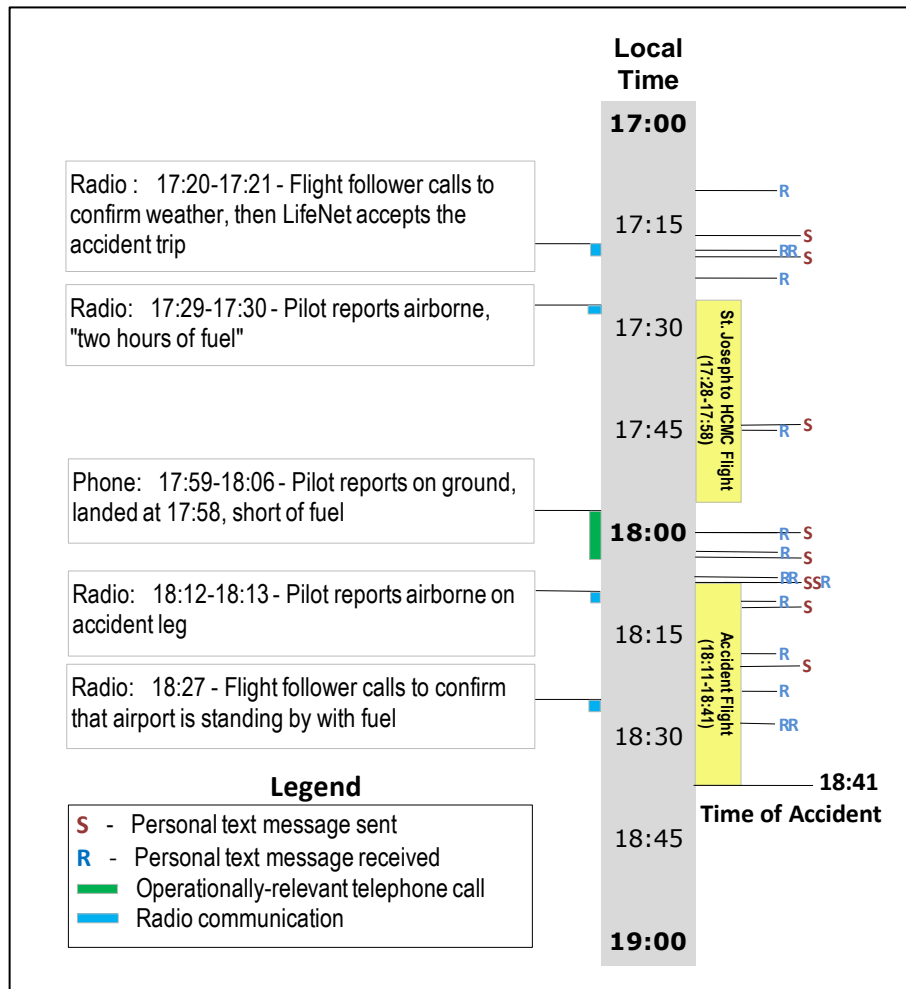
Figure 6b. Timeline of the pilot’s communications from 1700 to the accident about 1841.

Figure 6b, which covers the time period from 1700 to the accident, shows that text messages were sent from the pilot’s cell phone during time periods when the helicopter was in flight on the accident leg and the preceding leg and while the helicopter was on the Harrison County Community Hospital helipad.
